# Funktionsstabilitet

**Welding  
Mechanics  
Laboratory**

**Per Lindström Lussi, *Ph.D. IWE*, Senior Lecturer/Associate Professor**  
**Marine Technology**

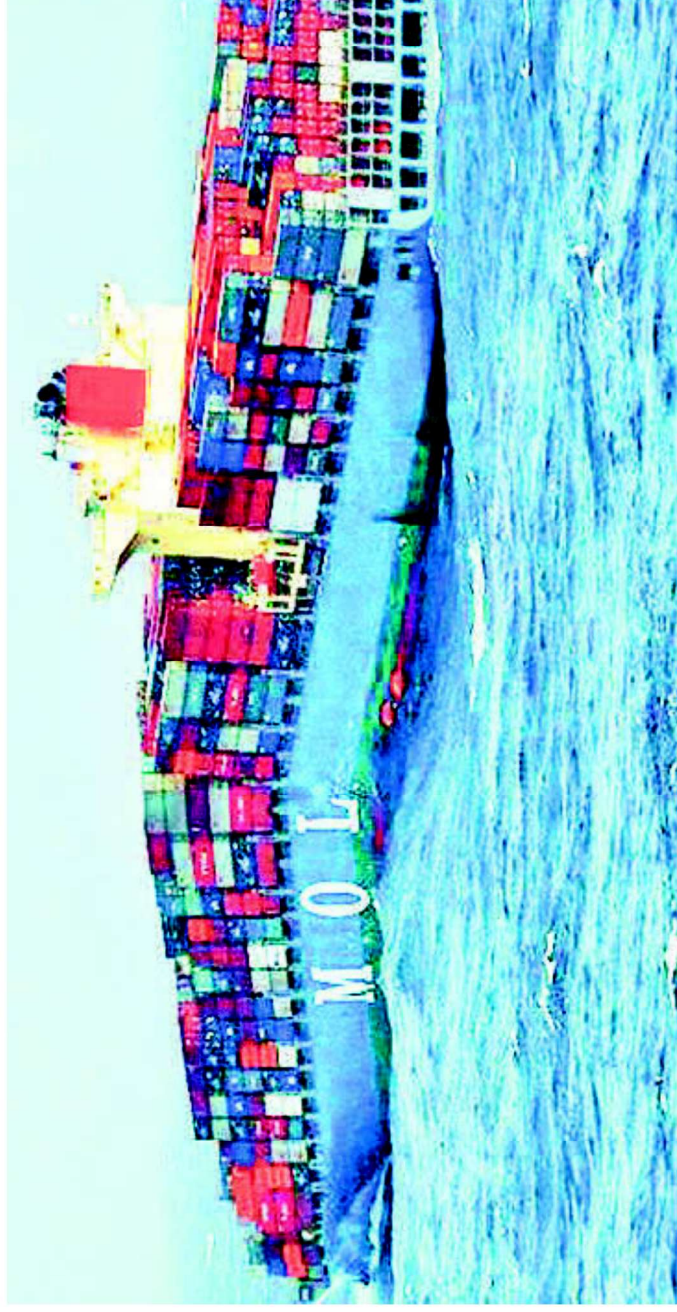
M/S MOL Comfort, Juni 2013

# Buckling
